# An Experimental Study on the Fatigue Response of 15-5 PH Stainless Steel Built by DMLS

*The present study is focused on the fatigue strength of 15-5 PH stainless steel parts built by DMLS. Four sets of specimens were manufactured, mechanically and thermally treated, and tested under rotating bending fatigue. The samples of the first two sets were built with their longitudinal axis perpendicular or parallel to the vertical stacking direction. In both cases, a 1mm allowance was uniformly distributed. The samples of the third and the fourth sets were similarly generated, with the same orientations. The samples of the last two sets were built with cylindrical shape and with 3mm allowance at gage. The results, processed also by analysis of variance tools, indicate that, considering the first two sets, the fatigue limit, approximately 39% of the ultimate strength, is almost independent of the build orientation. Conversely, the samples with incremented allowance, which required significant machining at gage, exhibit a much higher fatigue limit, very close to the commonly accepted reference value of one-half of the ultimate strength. This is quite an interesting result, as machining see

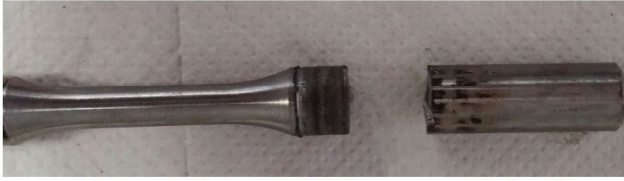
Figure 4: Unexpected failure at sample head

The results of sets #2 (vertically built, with uniform allowance), #3 (horizontally built, with greater allowance at gage) and #4 (vertically built, with greater allowance at gage) are respectively reported in Tables 7-9, where the same data are present. A not failure outcome indicates that the trial was stopped upon run-out without breakage occurrence. In the case of failure, it was of course checked that specimen separation had occurred at gage. Afterwards, the fracture surfaces were observed to make sure that a fatigue initiation and propagation mechanism was actually responsible of the observed failure. Most failures regularly occurred at gage, but in two cases, for the same sample set (Set #4), unusual and unexpected failures at specimen heads were observed. One of these failures is depicted in Fig. 4. It must be remarked that this outcome is not completely new, as it had also been observed (again in two cases) in the previous research regarding Maraging steels. In that study, an analysis by dye penetrants had indicated the presence of some spots of unconformable roughness, which were likely to have triggered the crack in combination with the clamping

The samples that were involved in the aforementioned outcome were of course discarded for further processing regarding the fatigue response. The final outcomes of these two trials are therefore tagged as NOT VALID in Table 9. The other results were anyway sufficient to determine both the sloping part of the S-N curve and the fatigue limit.

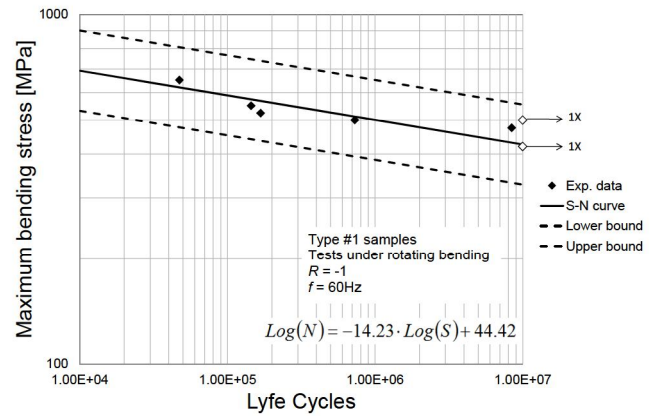
Figure 5: S-N curve for type #1 specimens (arrows indicate run-outs)

The results reported in the previous Section were initially processed, in order to determine the fatigue curves in the finite life domain. The S-N curves, retrieved as linear regressions in double logarithmic scale, are plotted in the graphs in Figs 6-9 for sets #1 to #4 respectively. The corresponding equations that yield the expected life as a function of the actual stress level are included in the figures. The related maximum likelihood bands at the 90% confidence level and the experimental data are also plotted in the same diagrams, following the recommendations of [18]. The experimental results can be generally well fitted along a straight line with a linear correlation coefficient ( $R^2$ ) up to 0.8.

The slopes of the interpolating lines were also determined during the regression procedure. The angle between the S-N line and the vertical axis is  $86^\circ$  for set #1,  $88^\circ$  for set #2,  $88^\circ$  for set #3 and  $85^\circ$  for set #4. The resulting inclination can be compared to those of the S-N curves determined for Maraging Steel MS1: considering Ref. [7] the angles of the determined curves were ranging between  $75^\circ$  and  $80^\circ$ . The generally higher angle retrieved for stainless steel indicates that its S-N curves have a less steep trend, where small variations of the state of load may correspond to huge variations of the fatigue life, from the order of  $10^5$  to almost  $10^7$  cycles. A great role seems to be due to the level of roughness: as documented by the data in Tables 2-5, related values were quite low in this study, ranging from  $0.2$  to  $0.3\mu\text{m}$  as an average. The experimentations reported in [19-20] were performed on samples of the same material and with comparable roughness and led to a nearly horizontal curve, with a similar slope. Conversely, the experimentations in [2], involving the same stainless steel produced by SLM, were performed on samples with a 10-time higher roughness and led to a much lower fatigue resistance with a particularly sharp drop of the curve for increasing life (corresponding to a much lower angle).

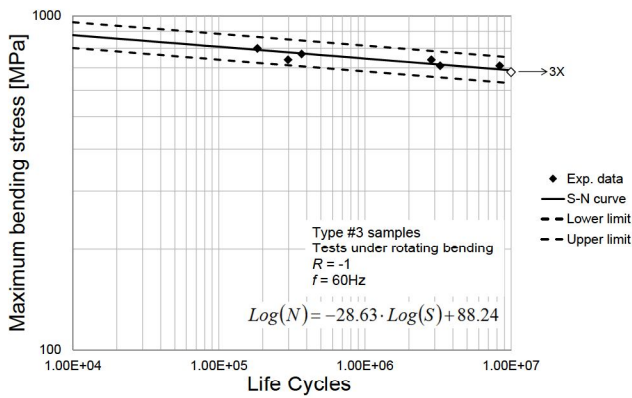
Figure 8: S-N curve for type #4 specimens (arrows indicate run-outs)
